M5 Motorway repair completed with minimal lane closure time

The SAFETRACK® Crack Infill system reinstates and protects M5 Motorway

Project M5 Motorway
GCP Solutions SAFETRACK® Crack Infill System

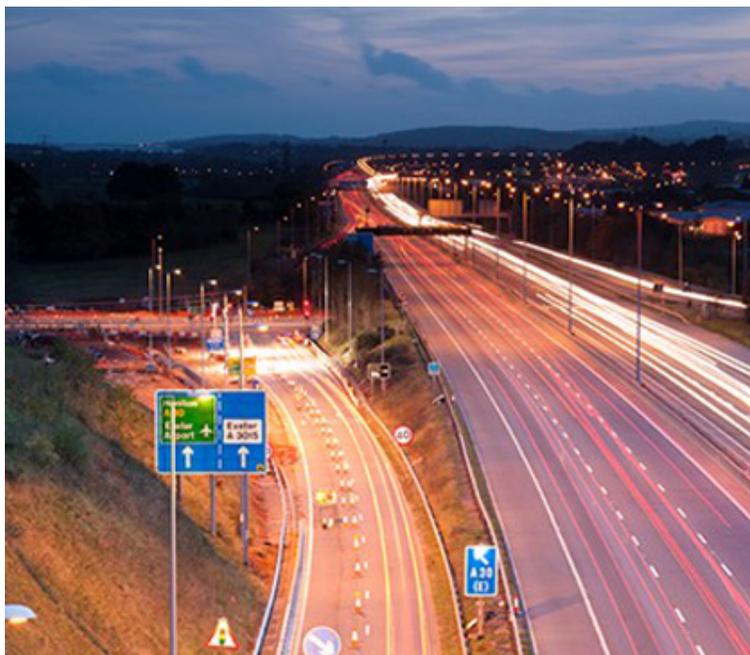
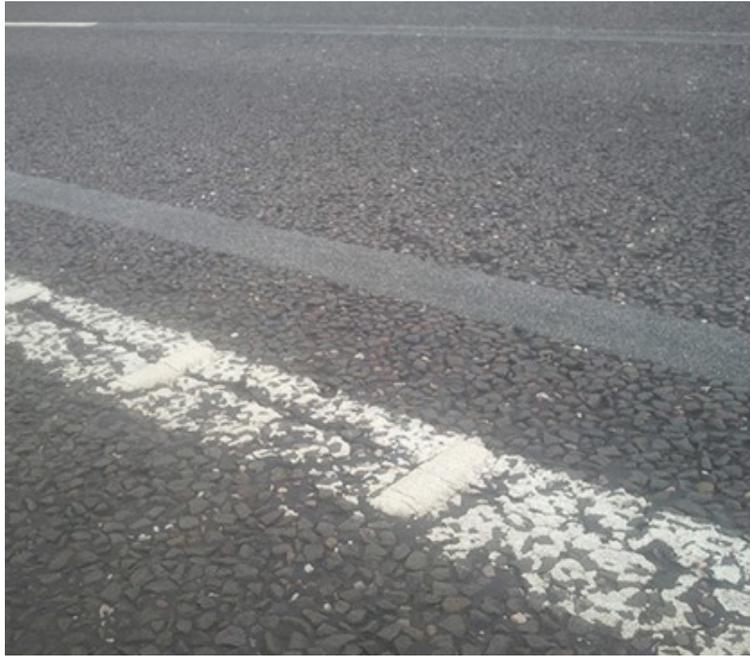
The team used SAFETRACK[®] Crack Infill with a revolutionary new machine application process that is safer, more efficient and more cost effective than traditional techniques. Using this process on the M5, the joint was prepared and then filled and sealed with the SAFETRACK[®] Crack Infill.

The works were carried out over eight night time closures of the road, leaving an eight hour window to set out the traffic management, prepare the crack, apply the SAFETRACK[®] Crack Infill system and remove the traffic control. The fast curing time of the system enabled approximately 1,000 linear meters per hour to be treated. In addition, the rapid cure of the bespoke resin meant that application could continue up to 30 minutes before the traffic management was due to be removed, and the road returned to full traffic load just 30 minutes later.
