M5 Motorway repair completed with minimal lane closure time

The SAFETRACK® Crack Infill system reinstates and protects M5 Motorway

M5 Motorway

SAFETRACK® Crack Infill System

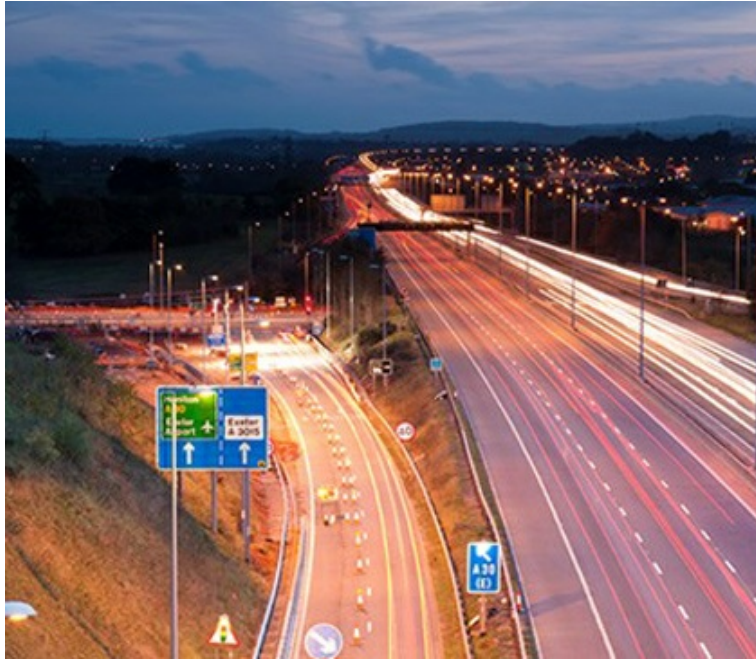
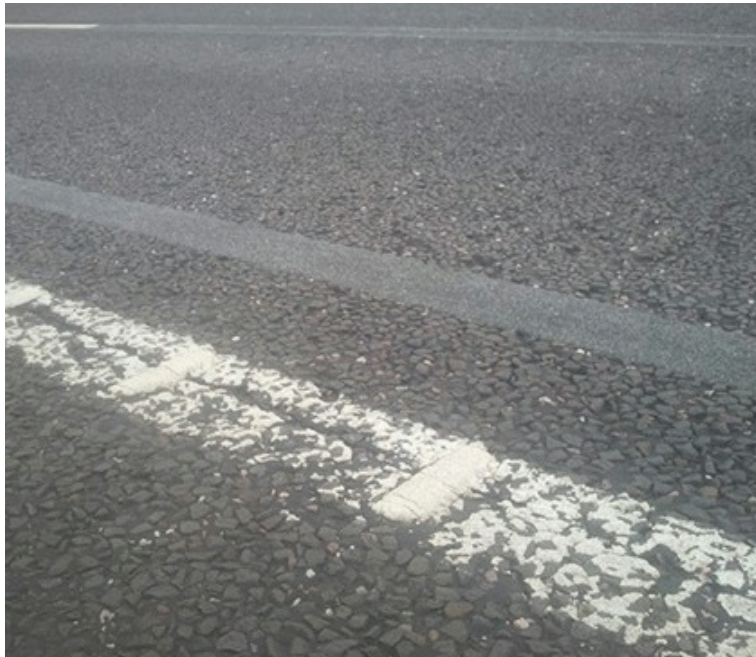
Aging asphalt surfaces on the M5 are generally in serviceable condition, but like many older asphalt surfaces, they are suffering from degradation at the joints between the asphalt mats. As water gets into the joints, hydraulic action and abrasion from vehicles opens up the joint.

The team used SAFETRACK[™] Crack Infill with a revolutionary new machine application process that is safer, more efficient and more cost effective than traditional techniques. Using this process on the M5, the joint was prepared and then filled and sealed with the SAFETRACK[®] Crack Infill.

The works were carried out over eight night time closures of the road, leaving an eight hour window to set out the traffic management, prepare the crack, apply the SAFETRACK[®] Crack Infill system and remove the traffic control. The fast curing time of the system enabled approximately 1,000 linear meters per hour to be treated. In addition, the rapid cure of the bespoke resin meant that application could continue up to 30 minutes before the traffic management was due to be removed, and the road returned to full traffic load just 30 minutes later.
