# TB-0910 — DCI® Results of FHWA Sponsored Corrosion Studies

This engineering bulletin discusses work done by Wiss, Janney & Elstner Assoc. (WJE) who examined the effectiveness of calcium nitrite corrosion inhibitor and other corrosion protection systems for protecting steel in concrete. The WJE research was sponsored by the Federal Highway Administration (FHWA) as well as members of private industry. Several conclusions were made as a result of this study, including:

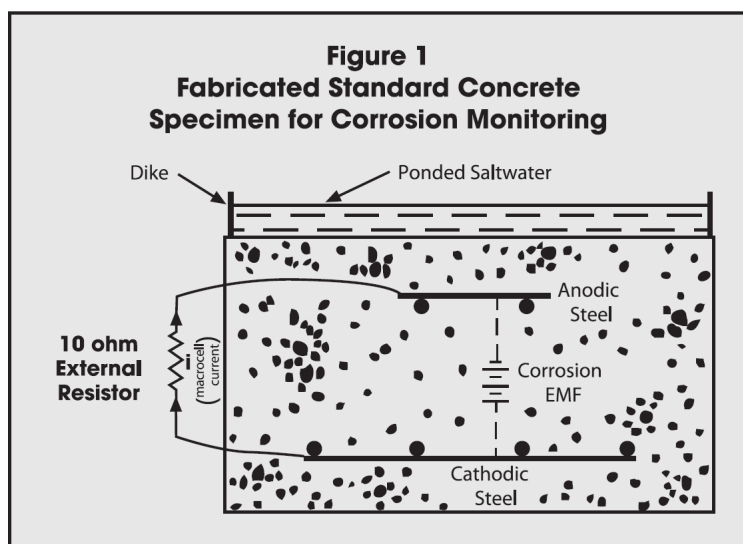
Figure 1

Two different test procedures were run. The first included minidecks, pictured in Figure 1. Macrocell corrosion was measured by setting up a galvanic cell. Two pieces of rebar were cast near the top of the sample, and four pieces of rebar were cast near the bottom of the sample. A dike was built around the top surface of the sample and filled with saltwater. The chloride ions from the salt diffused through the concrete, reaching the upper mat of rebar. Since no chloride ions reached the lower mat during most of the test, these four rebars did not corrode. A galvanic cell was created by electrically connecting the upper and lower rebar mats, in order to increase the corrosion rate of the upper, or anodic, mat of steel.

- Measuring the voltage across a resistor connecting the upper and lower mats, to calculate the macrocell corrosion current. The corrosion current is directly proportional to the corrosion rate.
- Measuring the macrocell driving voltage. This is measured immediately after uncoupling the top and bottom rebar mat. A higher driving voltage indicates a higher corrosion rate.
- Measuring the potential of the rebar with respect to a copper/copper sulfate half cell.

For this test, water/cement ratios ranged from 0.32 to 0.50 and concrete cover ranged from 25 to 75 mm (1 to 3 in.). The FHWA sponsored the test for 48 weeks and WJE continued the testing for a total of 116 weeks.

The most accurate method of measuring corrosion rates is monitoring the corrosion current. Although the macrocell corrosion current has limited accuracy, the parameters in this experiment are within those limitations. Chloride concentrations were also determined.

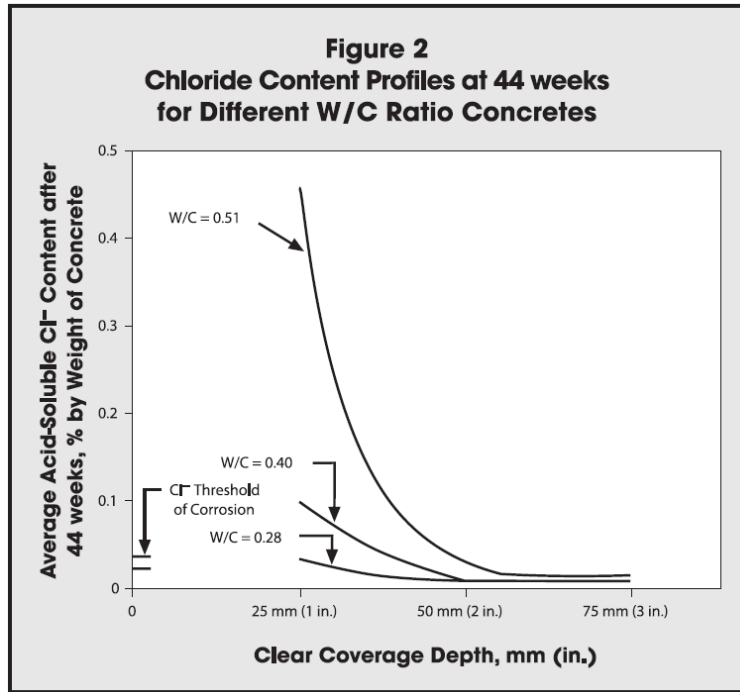
Figure 2

Lower water/cement ratios also decreased the rate of chloride ion diffusion through the concrete. As shown in Figure 2, the amount of chlorides at the rebar was lower, and the onset of corrosion was delayed in samples with lower water/cement ratios. As a result, the FHWA suggested that a ratio of no more than 0.44 be used. Many other studies have arrived at similar conclusions.
