M8 Motorway slip road repaired and protected for the long term

SAFETRACK® Inlaid Road Repair prevents water ingress

Project	M8 Motorway Slip Road
Client	Transport Scotland
Contractor	LMS Highways
GCP Solutions	SAFETRACK® Inlaid Road Repair System

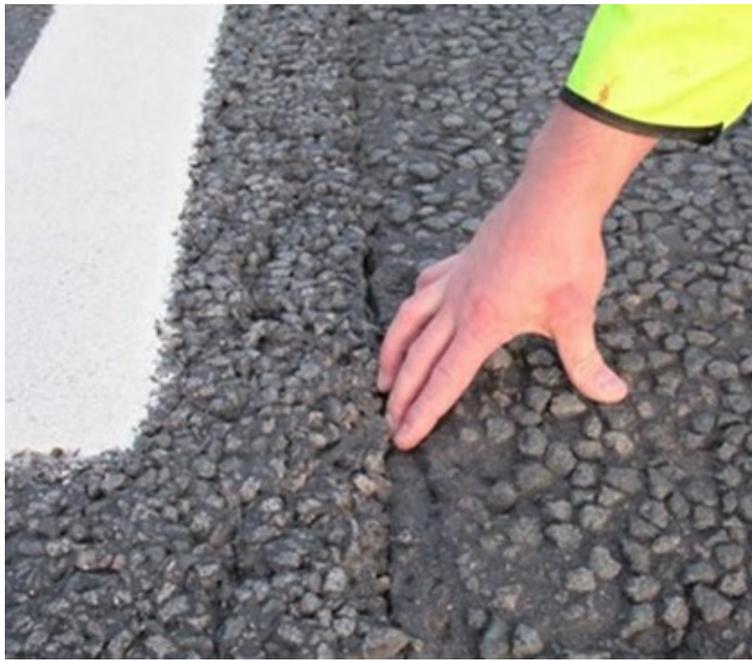
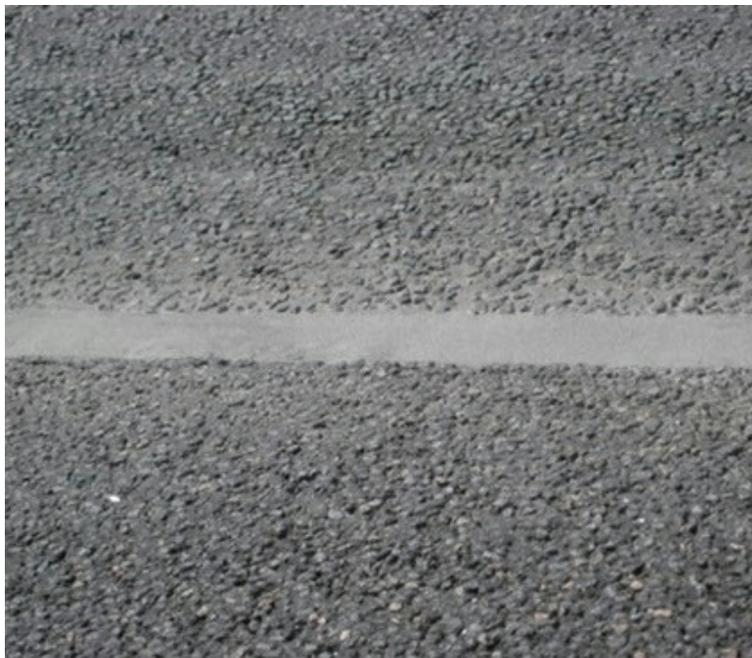
The fretted joints of the M8 needed repairing and sealing to prevent water ingress and further damage to the otherwise sound asphalt. The repair also needed to be strong enough to cope with high volume heavy goods vehicle traffic and the additional loads created by acceleration/declaration and transverse loading across the joint during lane changes.

A rapid repair system was required to reduce disruption to road users during the maintenance project. The client required a recessed repair where the repair system is installed into a formed recess to make it flush with the surface. Traditionally inlaid systems have been slow and consequently expensive to install, with unacceptable levels of traveller disruption.

The client selected the HAPAS-approved SAFETRACK[®] Inlaid Road Repair system, developed by Stirling Lloyd (now GCP Applied Technologies). A micro milling technique was also developed to reduce the amount of asphalt milled from the surface prior to inlaying the repair system. Based on unique ESSELAC[®] technology, the SAFETRACK[®] repair systems includes a unique resin that enables a thinner recessed repair to be achieved than would be possible with a traditional asphalt-based material. Less milling and less materials applied increases the speed of application and reduces cost and disruption.

The system's rapid cure meant that the road could be returned to full traffic load in as little as half an hour after installation, since there was no residual heat to be lost from the system. The system enabled more than 200 linear meters of fretted joint to be repaired per hour.
