High-performance Waterproofing Protects Bridge Deck

ELIMINATOR® and METASET® systems used on £1.5m Putney Bridge repair and refurbishment project

Project	Putney Bridge, London, UK
Client	Wandsworth Borough Council
Contractor	FM Conway
Authorized Contractor (Waterproofing Applicator)	Metrail Construction Ltd
GCP Solutions	ELIMINATOR® Bridge Deck Waterproofing and METASET® systems

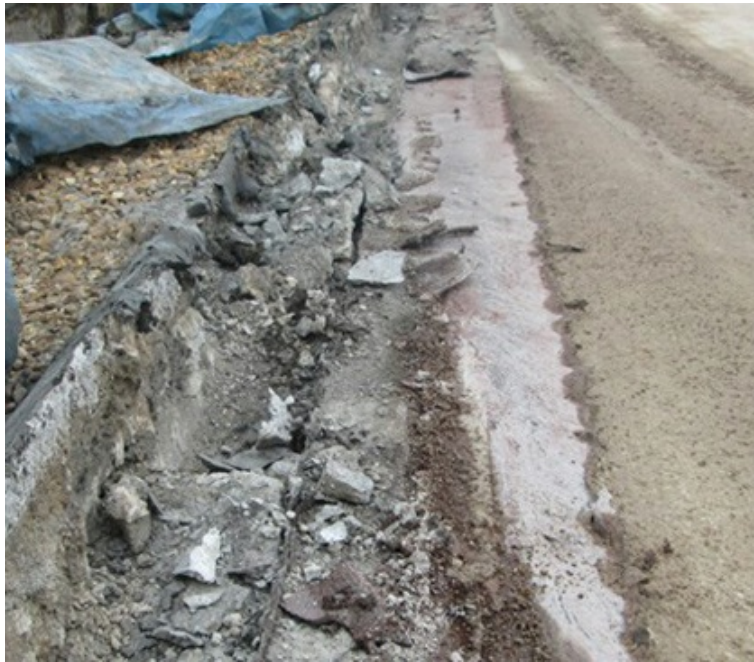
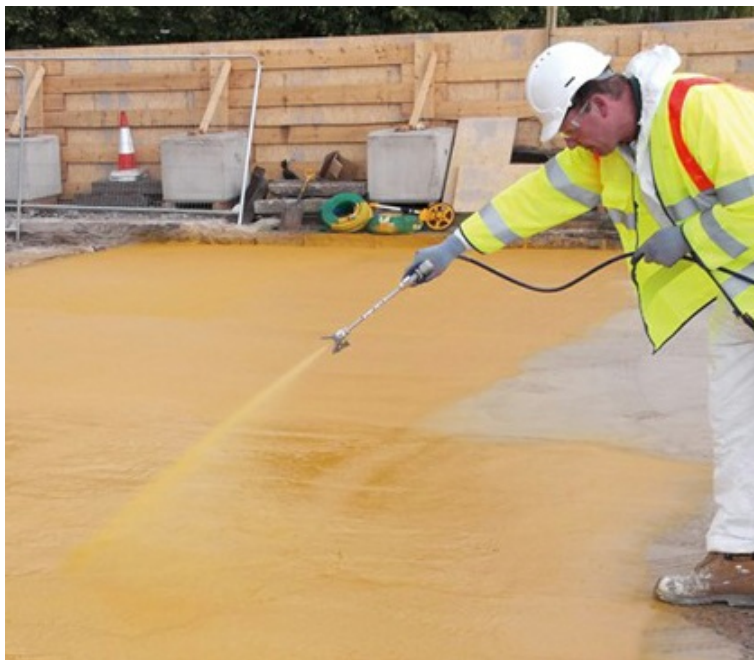
The Grade II listed arch bridge which crosses the Thames had a Ground Penetrating Radar (GPR) report undertaken in 2010, which identified the deck as having areas with significant moisture and even saturation within its roadway and supporting structure. The bridge was in need of protection from water penetration to prevent structural damage.

On site, the existing surfacing and waterproofing, along with the curb detail, were removed by main contractor, FM Conway. Wandsworth Council's in-house engineering consultancy assessed the bridge structure and found that the existing polyurethane waterproofing system had completely de-bonded and delaminated from the concrete substrate. In addition, loose, friable material needed to be replaced with a robust, concrete detail. Metrail Construction Ltd repaired the bridge, applied waterproofing, added new paving stone and upgraded the drainage system.

Wandsworth Council specified the **ELIMINATOR**[®] system from Stirling Lloyd (now GCP Applied Technologies) as an immediate, cost-effective solution for waterproofing the surface and curb areas since its fast cure time would reduce bridge closure times. **METASET**[®] Resifilla was chosen for the deck repair since it achieves very high early compressive strengths, excellent thermal and mechanical shock resistance and also cures rapidly across a wide range of temperatures.
