TB-0910 — DCI[®] Results of FHWA Sponsored Corrosion Studies

/ concrete / mix design

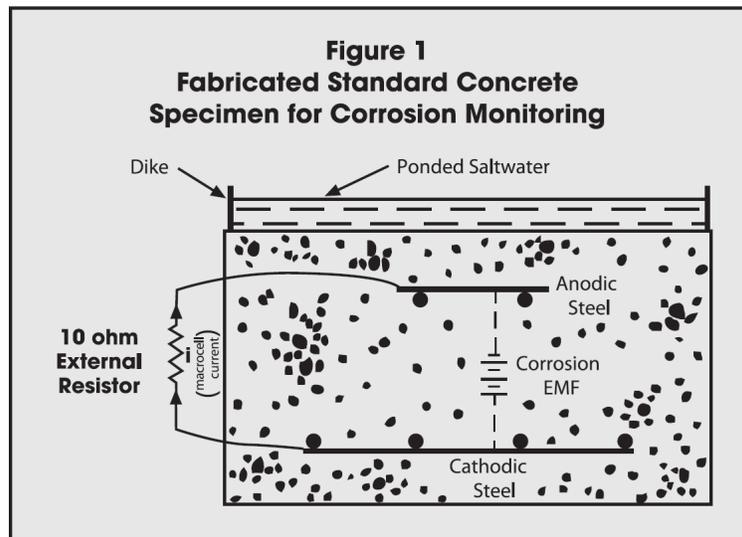
Figure 1

Two different test procedures were run. The first included minidecks, pictured in Figure 1. Macrocell corrosion was measured by setting up a galvanic cell. Two pieces of rebar were cast near the top of the sample, and four pieces of rebar were cast near the bottom of the sample. A dike was built around the top surface of the sample and filled with saltwater. The chloride ions from the salt diffused through the concrete, reaching the upper mat of rebar. Since no chloride ions reached the lower mat during most of the test, these four rebars did not corrode. A galvanic cell was created by electrically connecting the upper and lower rebar mats, in order to increase the corrosion rate of the upper, or anodic, mat of steel.

- Measuring the voltage across a resistor connecting the upper and lower mats, to calculate the macrocell corrosion current. The corrosion current is directly proportional to the corrosion rate.
- Measuring the macrocell driving voltage. This is measured immediately after uncoupling the top and bottom rebar mat. A higher driving voltage indicates a higher corrosion rate.
- Measuring the potential of the rebar with respect to a copper/copper sulfate half cell.

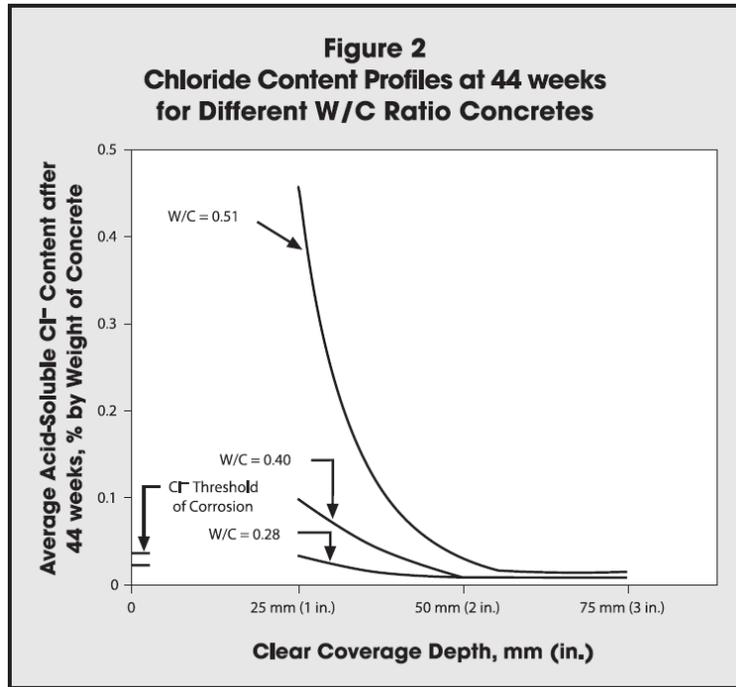
Figure 2

Lower water/cement ratios also decreased the rate of chloride ion diffusion through the concrete. As shown in Figure 2, the amount of chlorides at the rebar was lower, and the onset of corrosion was delayed in samples with lower water/cement ratios. As a result, the FHWA suggested that a ratio of no more than 0.44 be used. Many other studies have arrived at similar conclusions.
